MOLD REMEDIATION PROTOCOL

Client Name: Jordan & Taylor Sample
Property Address: 1450 Demonstration Way, Boca Raton, Florida 33496 Date of Inspection: March 10, 2026
Report Date: March 11, 2026
Inspected By: Christopher Finnegan
Florida Mold Assessor License #: MRSA 3454

SAMPLE PROTOCOL — All names, addresses and laboratory values are fictional.

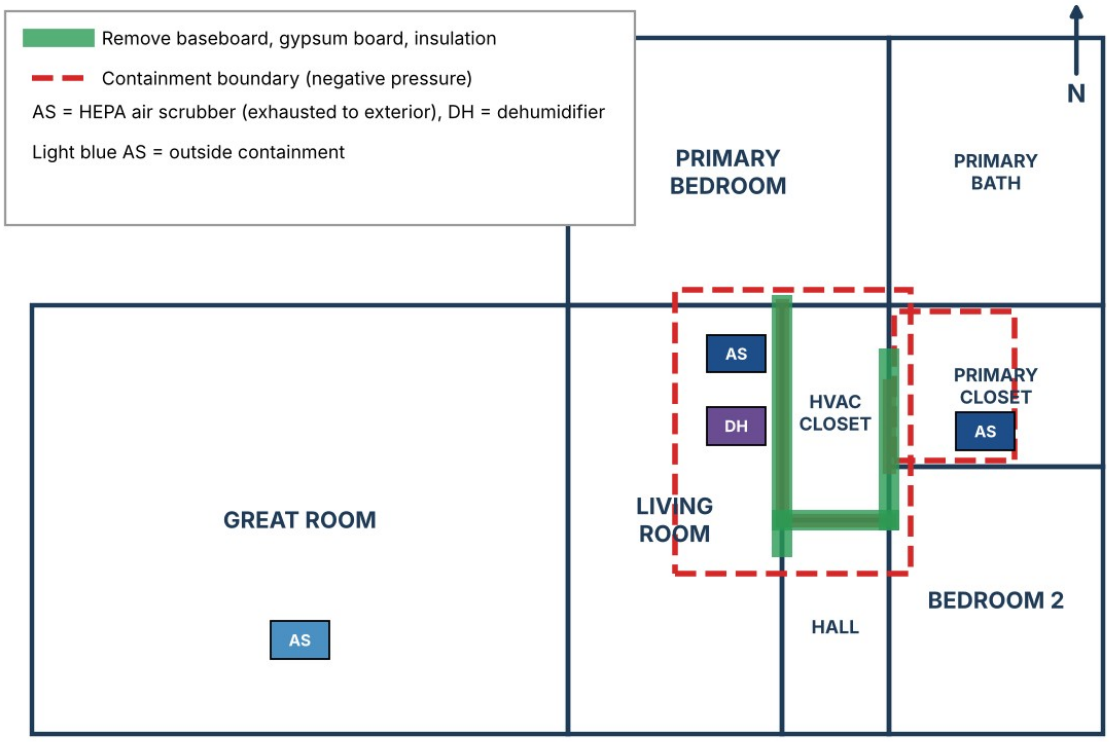
SAMPLE — Protocol Sketch (not to scale). First floor, 1450 Demonstration Way.

Water was reported to have overflowed from the air handler condensate drain pan in the first-floor HVAC closet of this two-story townhome and was discovered when the engineered wood flooring in the Living Room began to cup. Openings had been cut at the base of the HVAC closet walls by others before the assessment, without containment.

At the assessment on March 10, 2026, readings of 50.6 WME at the base of the Living Room wall shared with the HVAC closet and 56.5 WME at the Primary Closet wall adjoining it were recorded against a dry reference of 9.1 WME, with moderately elevated readings of 20.3 to 22.2 WME in the hall and Bedroom 2.

Visible growth was present at the base of the Living Room wall and within the HVAC closet cavity. Surface samples returned 6,240 spores per square centimeter at the Living Room wall base, predominantly Chaetomium, and 18,240 in the HVAC closet cavity, 100 percent Aspergillus/Penicillium-like, both with hyphal fragments.
In the air, the Living Room returned Aspergillus/Penicillium-like at 1,280 spores per cubic meter against 27 in the exterior control, with Chaetomium present; the Great Room returned 213. The Living Room wall base and the HVAC closet cavity are interpreted as Condition 3 under IICRC S520, and the Great Room as Condition 2.

HVAC Closet, Living Room and Primary Closet walls (Condition 3): Remove the baseboards, gypsum board and insulation floor to 24 inches above the highest point of measurable moisture or visible growth, and a minimum of 24 inches laterally beyond it, along the walls marked in green on the Protocol Sketch. Remove the remaining lower closet wall finishes around the existing openings. Inspect the exposed framing and cavities at the point of opening; any wet material or growth found beyond the marked areas is to be added to the scope.

Containment and equipment: Establish containment enclosing the HVAC closet and the adjoining portion of the Living Room, and a second containment at the Primary Closet, as marked in red on the Protocol Sketch, maintained under negative pressure. Run HEPA air scrubbers inside each containment, exhausted to the exterior, a dehumidifier within the Living Room containment, and an air scrubber in the Great Room outside containment.

Hall and Bedroom 2 (moderately elevated moisture): Remove the baseboards at the walls with elevated readings to allow the wall base to dry, and verify the gypsum board is dry to 8 to 10 WME. If readings do not return to the dry standard, or if growth is found behind the baseboard, add the affected material to the removal scope under containment.

Great Room and adjoining areas (outside containment): No removal of building materials. HEPA vacuum and damp wipe all horizontal and accessible surfaces in the Great Room and adjoining areas, including floors, baseboards, window sills and furnishings, once the removal work is complete, with the Great Room air scrubber running for the duration of the work. The cupped flooring is to be evaluated for replacement once the slab is verified dry.

Interim controls pending remediation: Keep the HVAC closet closed and seal the existing openings in the closet walls with plastic sheeting. Do not disturb the affected materials until containment and HEPA filtration are in place.

Containment, removal areas and equipment placement are shown on the Protocol Sketch below. Sample locations are shown on the sketch at Appendix C of the Mold Assessment Report dated March 11, 2026.
